The Stress Corrosion Cracking of Maraging Steels

A thesis submitted as a requirement for the degree  
of Doctor of Philosophy at the University of  
Newcastle upon Tyne.

P. M. Haigh, B.Sc.,

Department of Metallurgy,

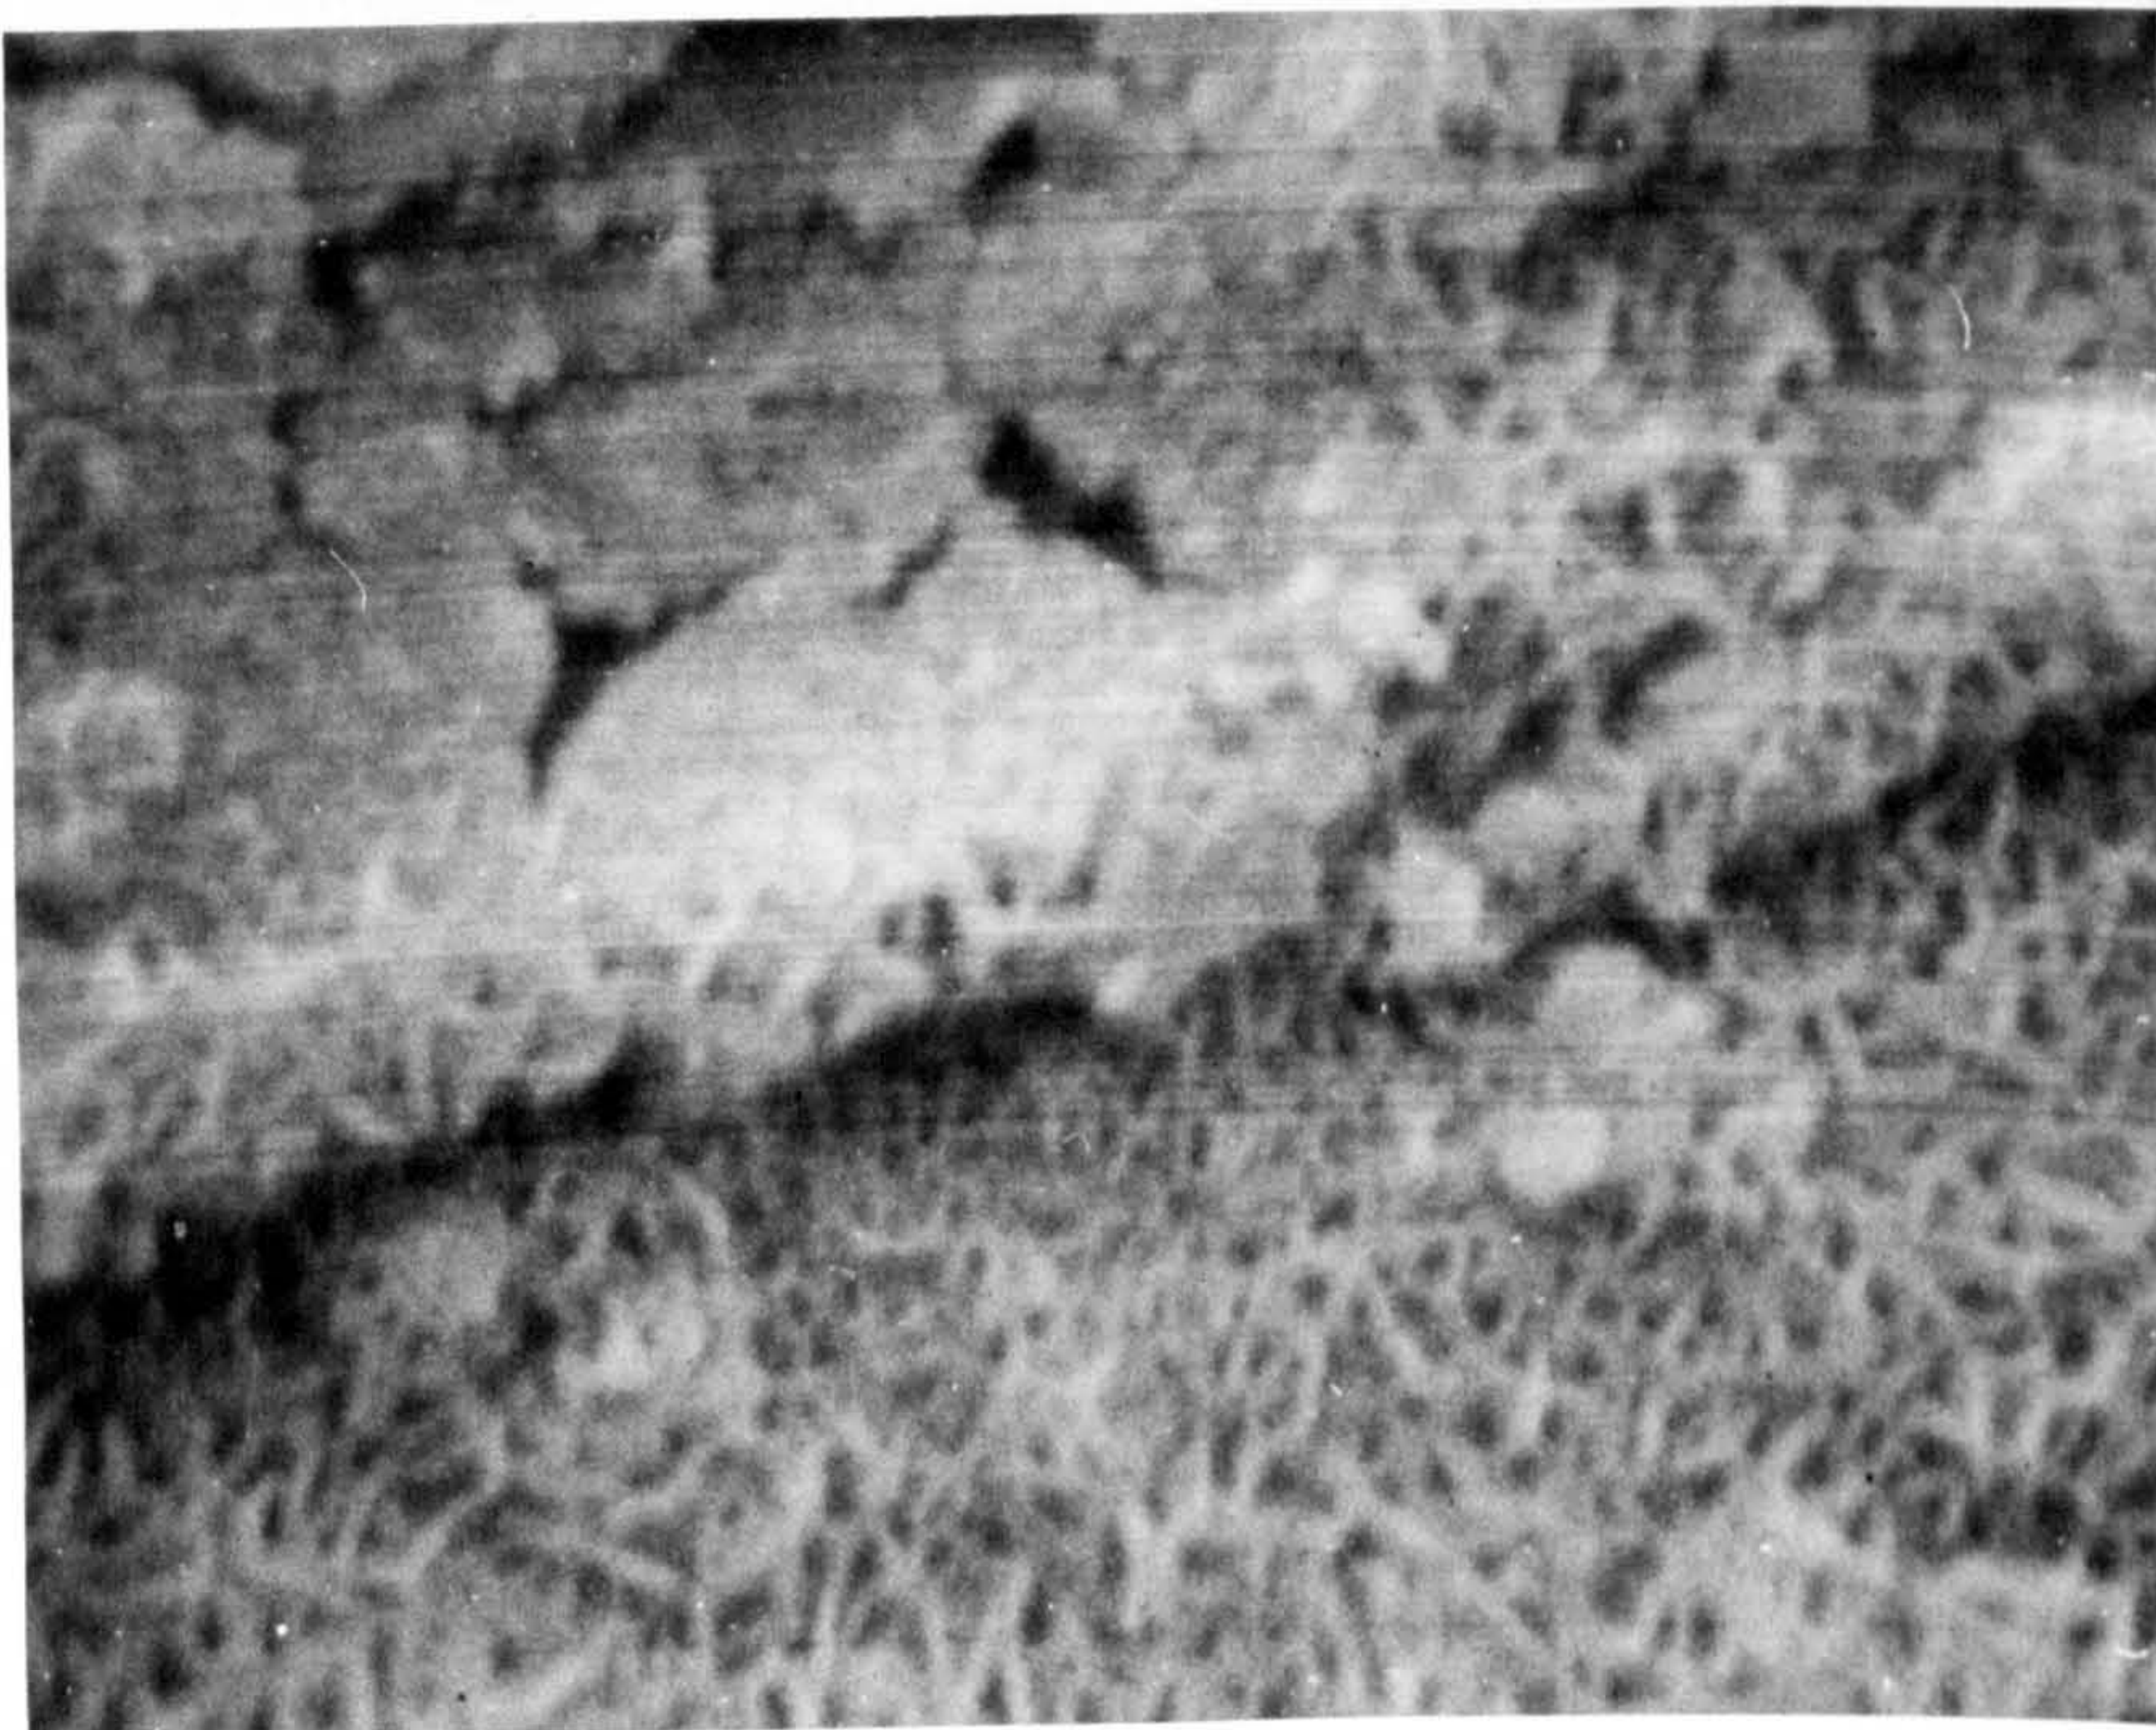
Fig. 3.70 Cleavage step of hydrogen embrittlement failure (24,000)

(Fig. 3.68). When intergranular areas were present these appeared featureless and showed no markings characteristic of cleavage (Fig. 3.69). The latter appeared to be of the continuous type, but on some steps evidence was found of what may be shear rupture (Fig. 3.70).
